REPORT NO. 3535  
SOUTHERN RAILWAY COMPANY  
IN RE ACCIDENT  
AT KNOXVILLE, TENN., ON  
OCTOBER 6, 1953

November 5, 1953

Accident at Knoxville, Tenn., on October 6, 1953, caused  
by a cut of cars moving out of control on a descending  
grade as a result of the premature release of hand  
brakes.

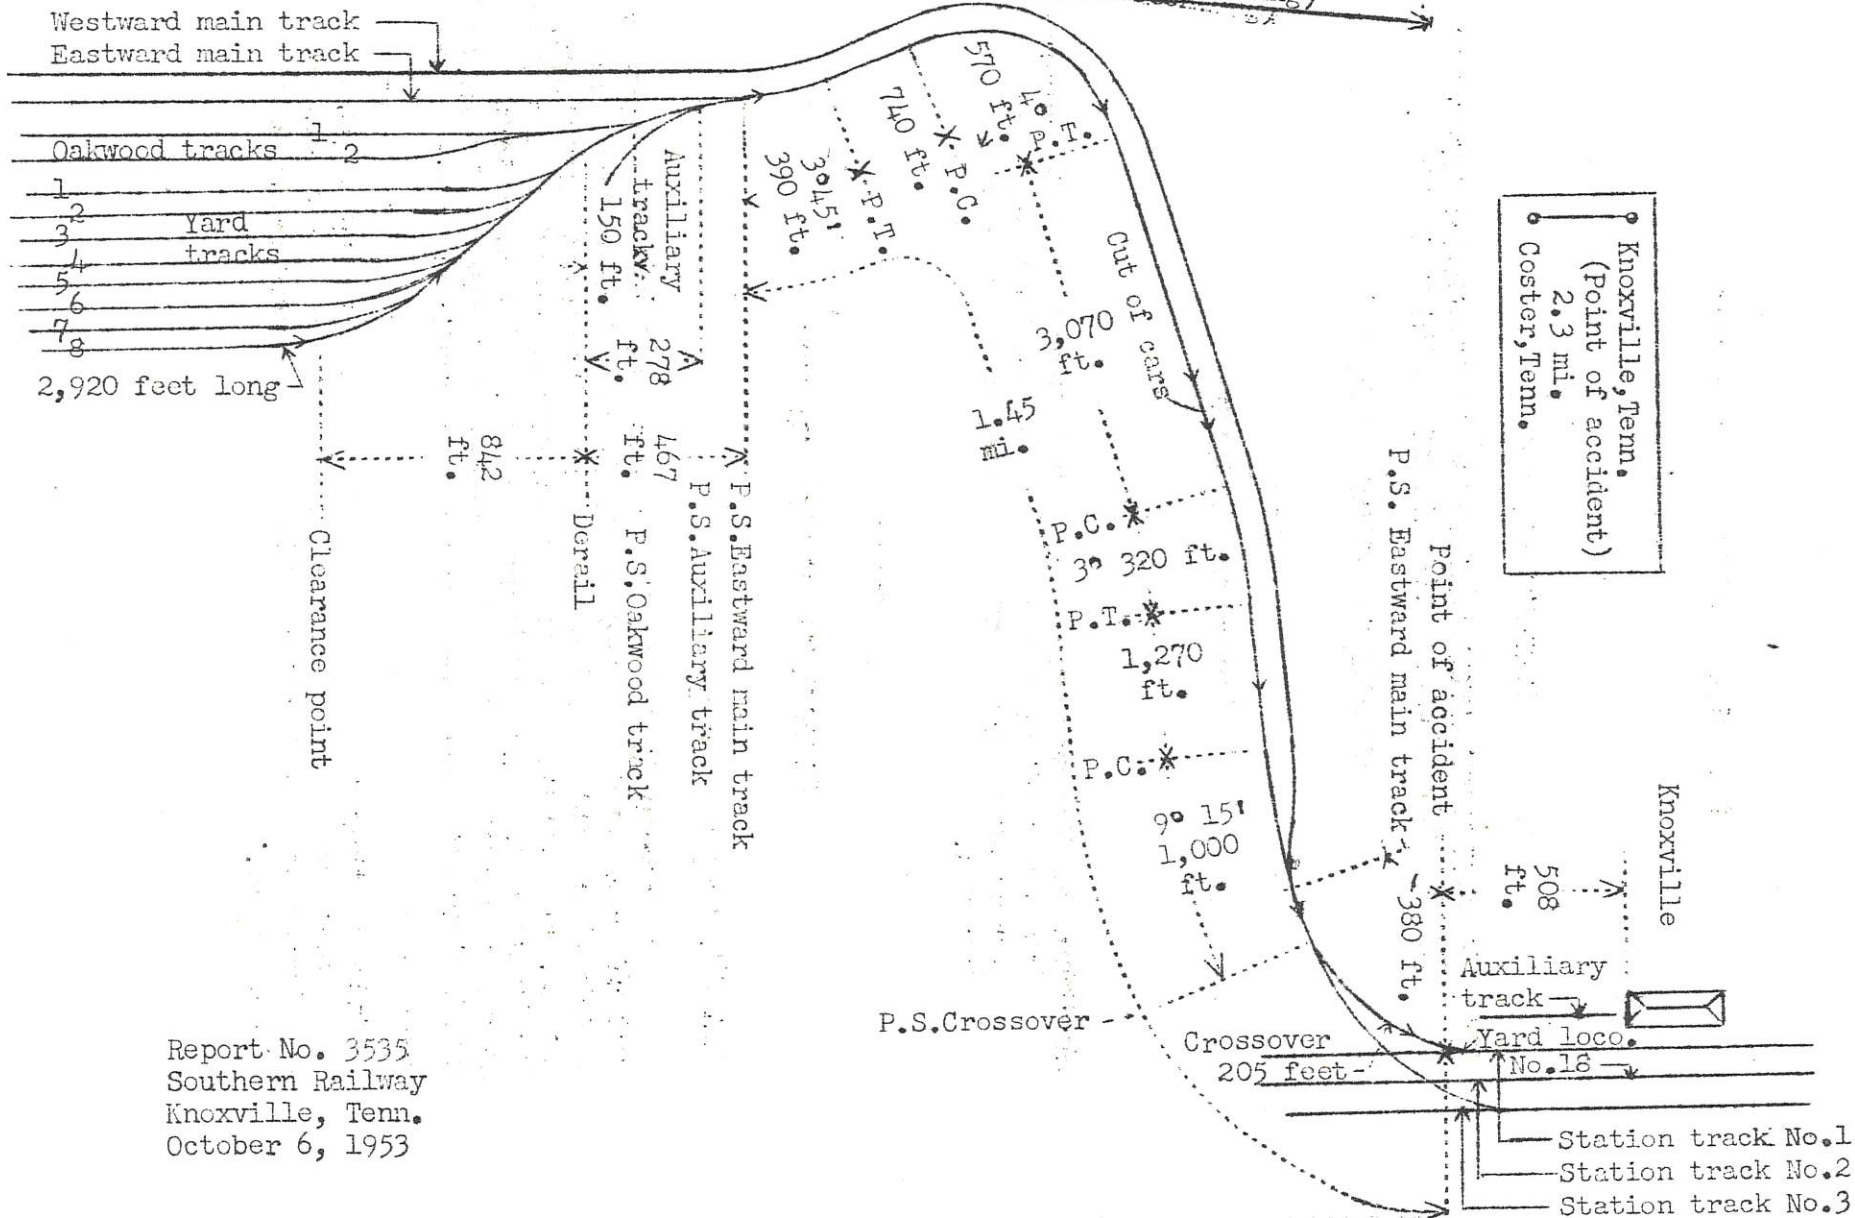
1.03 percent descending  
Coster

PROFILE  
1.61 percent descending and 1.08 percent ascending  
(Average gradient 0.40 percent descending)  
Varies between
